CASE STUDY: Property Management Company

LOCATION: PITTSBURGH, PA

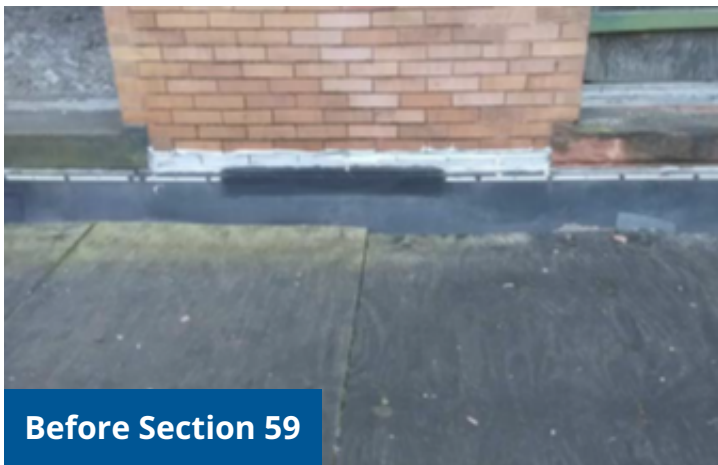
Before Section 59

- Section 59 over an office space that was experiencing leaks near the walls/brick angle changes
- Section 51 comprised of a pop-up roof in the middle of the main section over the manufacturing facility that was in need of restoration

Simon Roofing performed its extensive SR PreVision inspection and analysis across all of the roof sections to determine remaining useful life of each. On Section 59, it was determined that the roof section was failing to the point of not being able to be restored. The existing roof needed to be torn off and the SR 120p CLP+™ roof system, which is a seamless alternative to single-ply was installed. The five-course application waterproofed the counter-flashing to stop all leaks.
