# CASE STUDY:

# NATIONAL CONVENIENCE STORE

LOCATION: NEWPORT, NEW HAMPSHIRE

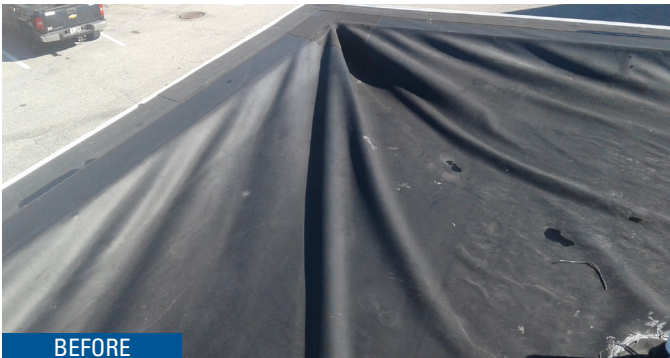
BEFORE

The customer had an aging EPDM roof that was installed incorrectly and as a result, was rapidly deteriorating. The previous roofing provider did not rust strip the surface, which caused the membrane to pull and develop severe wrinkles.

Simon Roofing identified the cause of the issue with a comprehensive SR PreVision inspection and analysis. After cutting, stretching and re-fastening the old EPDM membrane to remove the wrinkles, we installed our SAM (self-adhered modified) system over the existing membrane. Our unique process of liquid-applying Wite Brite™ and embedding Poly within the Wite Brite™ layers resulted in a watertight roof with a new, full 15-year warranty.
