CASE STUDY: FINANCIAL INSTITUTION

LOCATION: NEW HOLLAND, PA

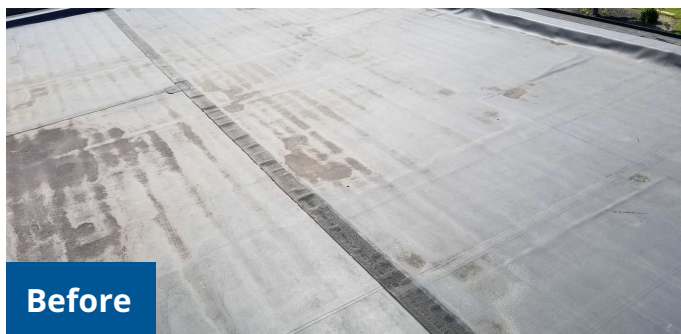
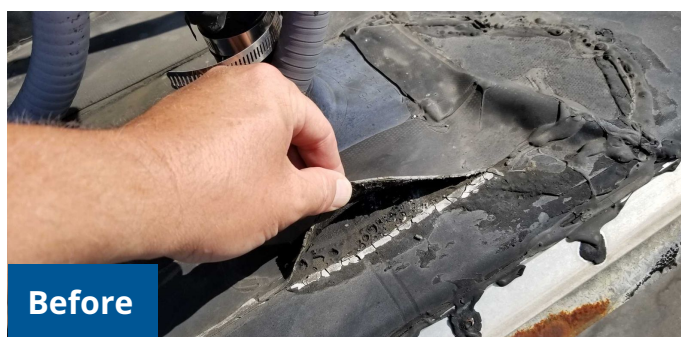
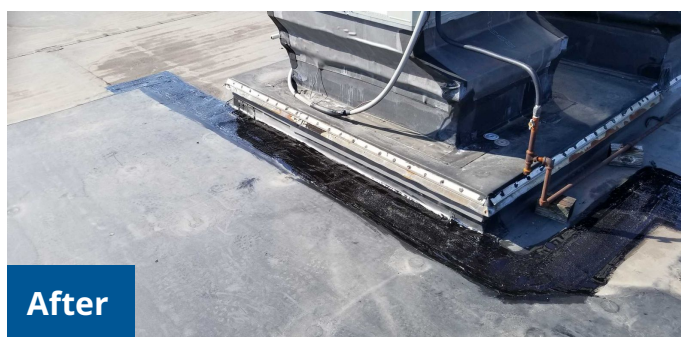
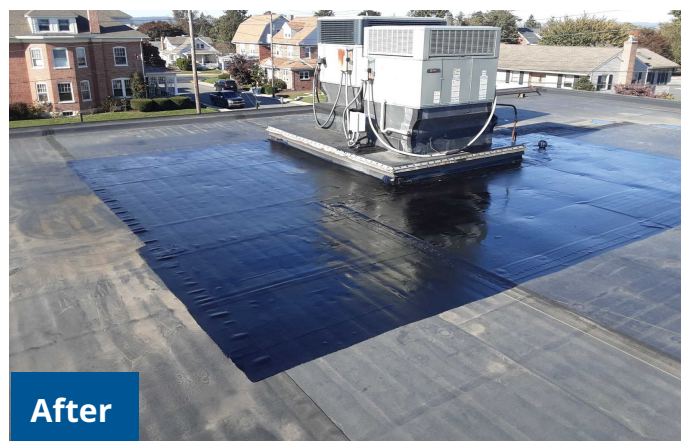
After arriving on-site, the technician first examined the internal entry points and took photos and measurements. All of this documentation was recorded directly into the technician's tablet for quality control and warranty purposes. The technician was able to identify loose laps on the roof as the source of the leak. The repair was then completed using a three-course solution comprised of Simon Roofing's self-manufactured product designed specifically for EPDM roofs.

Because roof leaks have a tendency to travel, the source of the leak and the actual water dripping inside may not be directly above one other. Coating the 100 sq. ft. around the repair allowed for a 2-year leak location warranty to cover not only the repair made on top of the roof, but also the leak within the building.

- Leak was resolved
- 2-year warranty covering both repair and leak location was issued
- Full documentation was provided to client through Simon's real-time, online customer portal
