# CASE STUDY: NATIONAL RETAIL STORE

LOCATION: SHAWNEE, OK

**Roof Type: Metal R Panel roof with exposed fasteners**

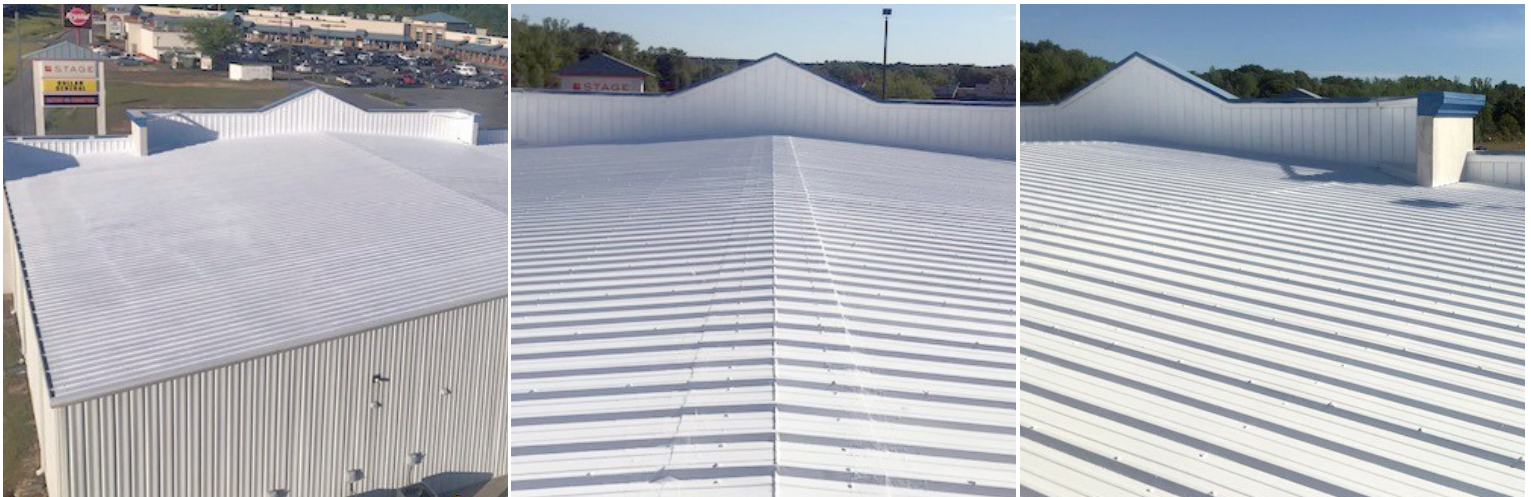
The metal roof on the retailer's building was experiencing multiple and consistent leaks. There had been numerous repairs completed on the roof, like stripping seams and patches to cover punctures and openings at penetrations. While these repairs stopped an immediate leak need, they made further repairs difficult. There were several panels that were warped or crushed due to excessive weight, and the exposed fasteners were beginning to rust, with some backing out or even missing. In addition, there were open seams, which could lead to significant moisture entry.

Simon Roofing first re-secured existing fasteners. They also replaced missing or rusted fasteners with new oversized fasteners featuring neoprene washers, which will help to eliminate future fastener issues. After these minor repairs were made, Simon Roofing installed the SR 520c restoration solution, which is a combination of Wite Brite™ cement, SR Poly and multiple layers of Wite Brite™ coating.
